Manhole Inspection Summary

Manhole # S15AA_042MH

Insp Date: **11/14/07 2:15 PM**

Location Address: **918 ASHBURTON ST**

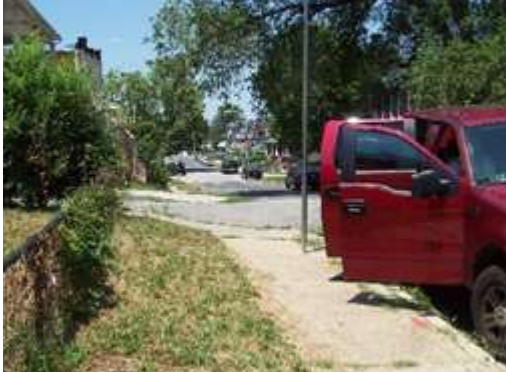
Location View

Enlarge the photo to see the MH

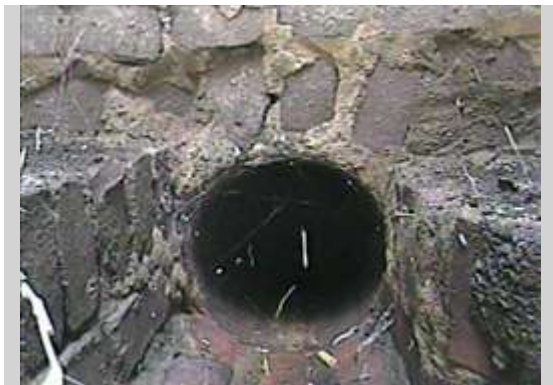
12 O'Clock Outflow

8 in. Circular Gravity Sewer
Pipe Out @ 12 O'Clock

Pipe Material: **Clay** ☐ Pipe Lined

Invert Depth: **5.90** (ft.) Flow Characteristics: **Slow**

Deposits: ☒ None ☐ Mud ☐ Sludge ☐ Debris ☐ Grease

Infiltration: **None** Pipe Seal Cond: **Sound**

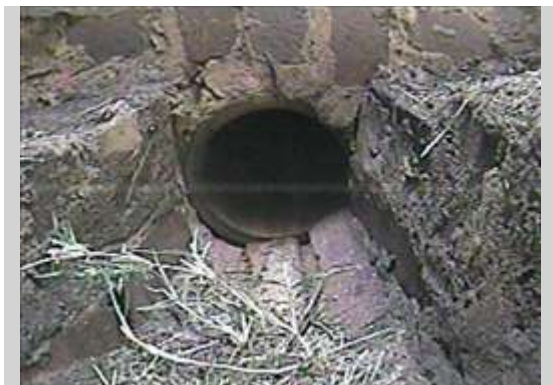
4 O'Clock Inflow

6 in. Circular Gravity Sewer
Pipe In @ 4 O'Clock

Pipe Material: **Clay** ☐ Pipe Lined

Invert Depth: **5.76** (ft.) Flow Characteristics: **Slow**

Deposits: ☒ None ☐ Mud ☐ Sludge ☐ Debris ☐ Grease

Infiltration: **None** Pipe Seal Cond: **Sound**

Connects To: **House connection / Service line**
